### Inspection Report

#### Minerals Regulatory Program

**Mine Name:** White Cloud  
**Operator Name:** Sutherland Brothers, Inc.

**Permit number:** S/015/044  
**Inspection Date:** February 22, 2006  
**Time:** 7:35-8:00 AM

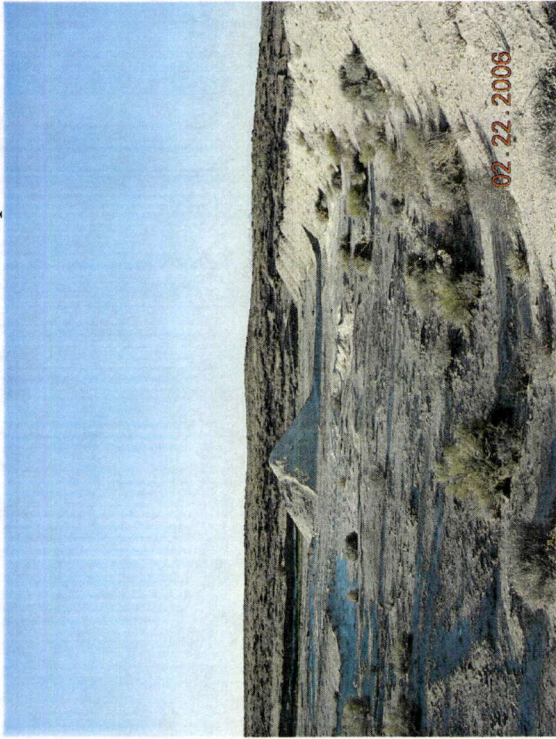
There is a windrow running approximately northeast/southwest through the middle of the disturbed area (Photos 1 and 2). To the southeast of this windrow (away from the highway), there are what appear to be a gypsum stockpile and two soil or overburden stockpiles (Photo 1 and barely visible in Photo 3). On the northwest side of the windrow are three more material piles. One or two of these appear to be gypsum and the other pile(s) is(are) soil.

Photo 1. View looking approximately southwest along the windrow. A gypsum stockpile is near the center of the photo.

The "pit" from which soil and gypsum were taken is shallow, and reclamation would be fairly simple. Gypsum would be spread in the bottom of the pit, and this would be covered with soil and overburden from the piles and windrow. The reclaimed area should be made to be free-draining.

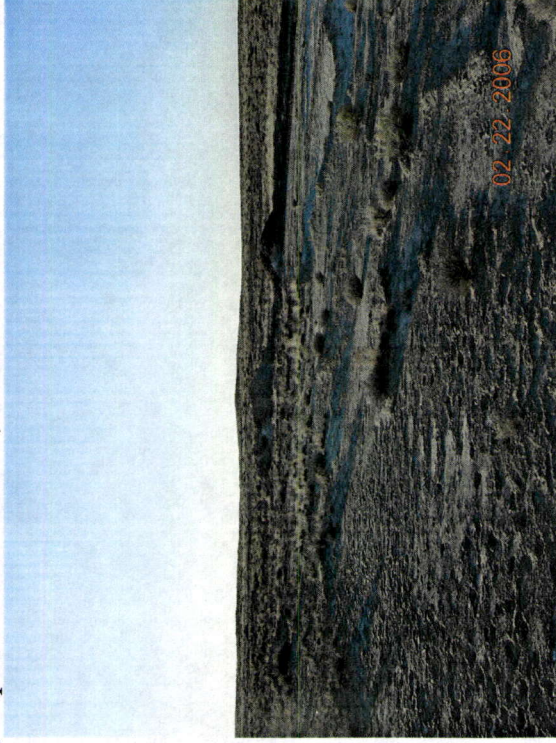
Photo 3. This picture shows two soil piles southeast of the windrow.

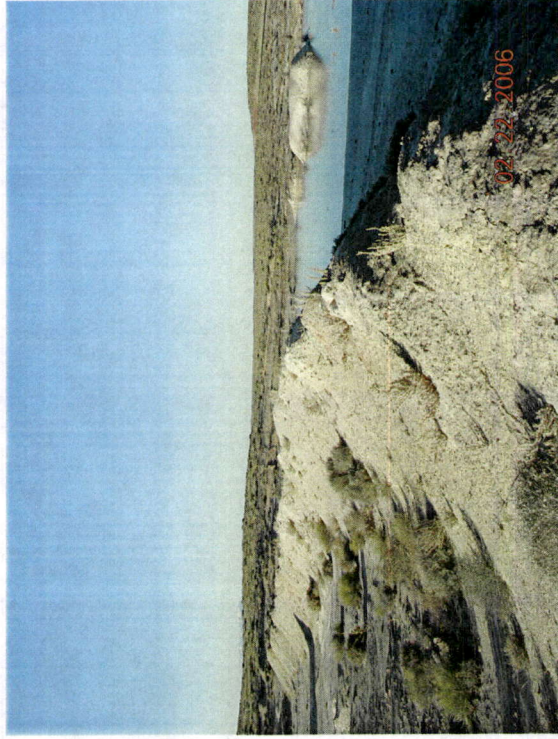
Photo 2. Another view of the windrow with one of the piles on the northwest side.

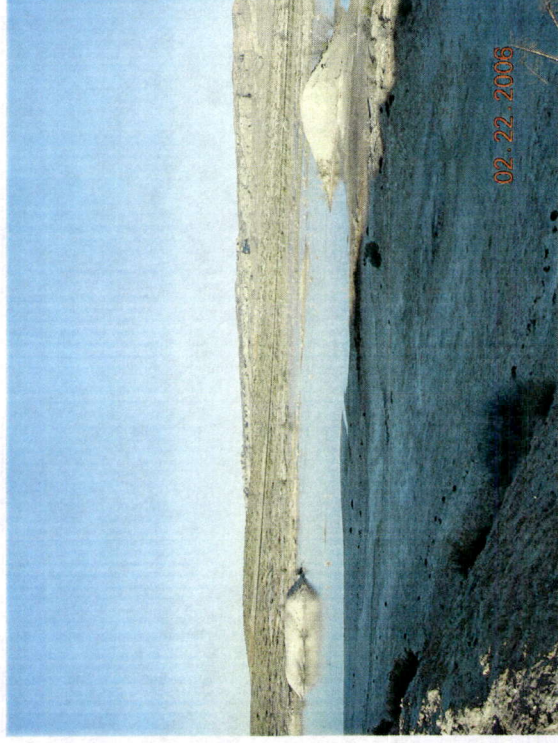
Photo 4. Area to the west of the windrow.
